## Test Report No. TL200529166

<b>Prüfgegenstand</b> Test Item	<b>AMC – Module with handle and latch mechanism</b>
<b>Identifikation</b> Identification	<b>Art. No.: 20849-040 // Art. No.: 20849-041 // Art. No.: 20849-042</b>
<b>Prüfauftrag</b> Test Order	<b>200x insertion / extraction cycles with full latch engagement through all three detent positions</b>
<b>Prüfspezifikation</b> Test Specification	<b>Assessment of latch mechanism operation</b>
<b>Auftraggeber</b> Test requested by	<b>Michael Joist / R&amp;D</b>
<b>Verfasser</b> Reported by	<b>Thorsten Lehm</b>
<b>Datum</b> Date	<b>25.08.2005</b>
<b>Unterschrift</b> Signature

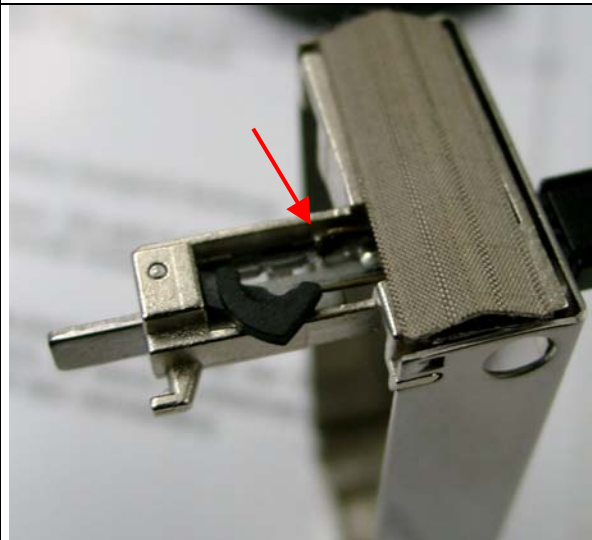
- After 200 activations, the latch spring popped out of its attachment point and was deformed
- Handle is not as easy to operate as prior to the beginning of the 200 activations

**Bild 5=**  
Deformed latch mechanism spring.
